July 31, 2023

**URGENT MEDICAL DEVICE CORRECTION**  
**FSCAs 2249723-06/02/2023-010-C, 2249723-06/02/2023-011-C,**  
**2249723-06/02/2023-013-C & 2249723-06/02/2023-014-C**  
**Datascope Cardiosave Hybrid and Rescue Intra-Aortic Balloon Pumps (IABP)**

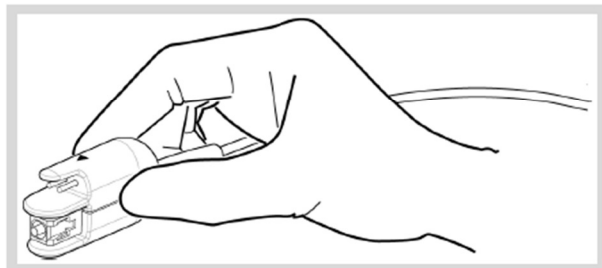
Figure 2-5: Grasping the Fiber-Optic sensor connector

Datascope/Getinge has received 187 complaints over a two-year period (January 1, 2021 through December 31, 2022) where Cardiosave IABP users were experiencing a failure in the IAB Fiber Optic Sensor input on the IABP when inserting the Intra-Aortic Balloon Fiber Optic connector.

The Fiber Optic connector is designed to fit smoothly into the IAB Sensor Input. The red triangle on the top of the connector should align with the red triangle on the Cardiosave console. Inserting the Fiber Optic connector into the port without verifying the correct alignment can lead to internal damage. If difficulty is encountered when inserting the connector, verify that the connector is in the correct position and attempt to reinsert into the IAB Sensor Input.

Excessive force can cause damage to the connector and the internal fiber optic assembly of the IABP console. This may cause a disruption in the fiber optic signal acquisition resulting in an inability to acquire a fiber optic signal on the Cardiosave IABP. Following proper insertion procedures will minimize the potential for damage to the connector and a loss of signal. This conclusion is based on field observations seen through the complaints evaluation. As part of Datascope's investigation testing will be performed to confirm this observation.

1. With one hand, grasp the Fiber-Optic Sensor Connector as shown in Grasping the Fiber-Optic sensor connector, with the red triangle visible on top.

Ensure that the red triangles on the Fiber-Optic IAB Sensor Connector and on the back panel are in alignment.

In step 4, when the Fiber-Optic connector is inserted into the IAB Sensor input until an audible “click” is confirmed, ensure that you are not using excessive force as that can lead to damage to the Cardiosave.
