February 2023

**URGENT FIELD SAFETY NOTICE  
MEDICAL DEVICE CORRECTION**

**Datascope Cardiosave Hybrid and Rescue Intra-Aortic Balloon Pumps (IABP)**

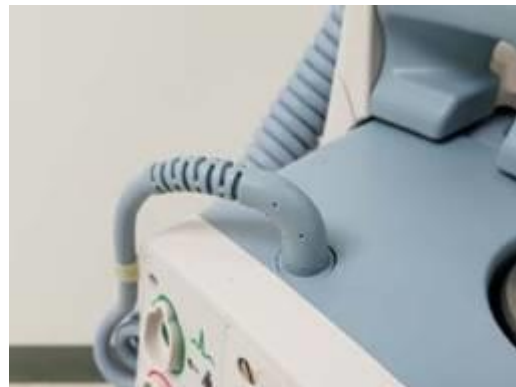
**Figure 1:** Representative picture of both the old and new Coiled Cable cord design.

An internal investigation of the complaints determined an unexpected shutdown may be due to damaged Coiled Cable Cords [part numbers 0012-00-1801 and 0012-00-1796] that provide bidirectional communication between the display head and base unit. Please refer to images below for reference.

Datascope/Getinge has received 25 reported complaints of damaged Coil cords resulting in unexpected shutdown over a 2 year period.

1. Prior to use of the Cardiosave IABP, inspect the coiled cable cord to ensure that there is no visible damage.

Datascope/Getinge has developed a hardware correction to address this issue. It is important to note that this issue is limited to units distributed prior to July 24, 2017. A Datascope/Getinge service representative will contact you to schedule the installation of the correction if your unit is affected as the correction kit becomes available. This work will be done at no cost to your facility.

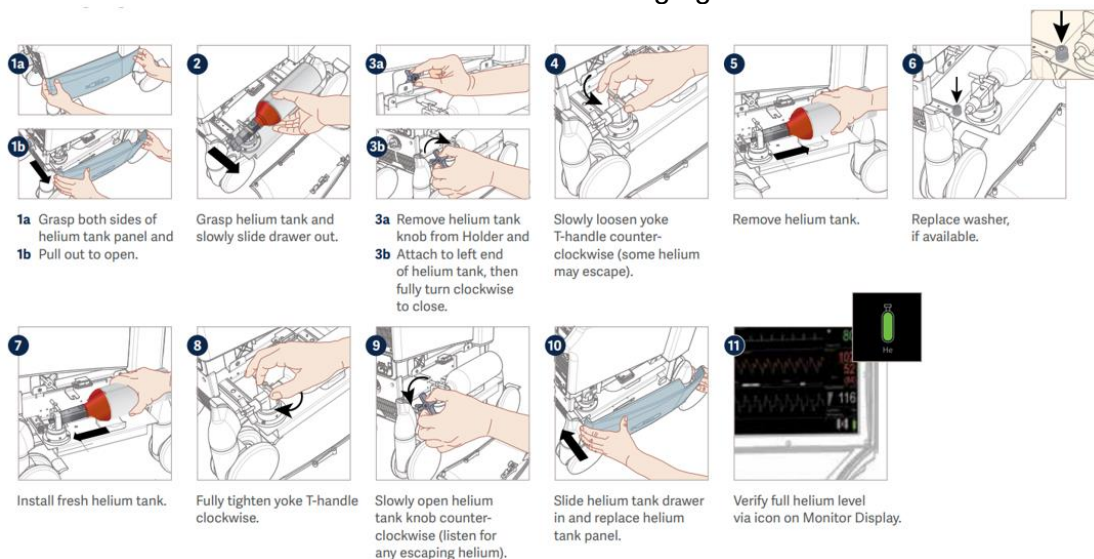
**Figure 2: As pictured in Cardiosave Hybrid and/or Rescue Operating Instructions**

There have been reported failures of the high pressure helium regulator which may cause a helium leak in the Cardiosave Hospital Cart. The high pressure helium regulator is located in the Cardiosave Hospital Cart and regulates the helium pressure of the external helium supply. In instance of helium regulator failure, a Pump Console's internal reservoir of helium will not be replenished when docked into an impacted Hospital Cart. This may result in an insufficient amount of helium within the internal reservoir. Please refer to images below for reference.

Datascope/Getinge has received 51 reported complaints of helium leak as a result of high pressure helium regulator failure over a 2 year period.

1. During Installation and Replacement of Helium Tank per the Cardiosave Operating Instructions, please ensure care is taken not to damage the helium tank or the helium tank yoke while inserting and/or removing the helium tank.
2. Please follow the instructions for use when changing the helium tank.

3. If user observes any visual damage on High Pressure Regulator, please contact your Datascope/Getinge service representative.

Datascope/Getinge is currently investigating this issue to determine root cause and will notify customers if additional action is to be taken to correct the issue.

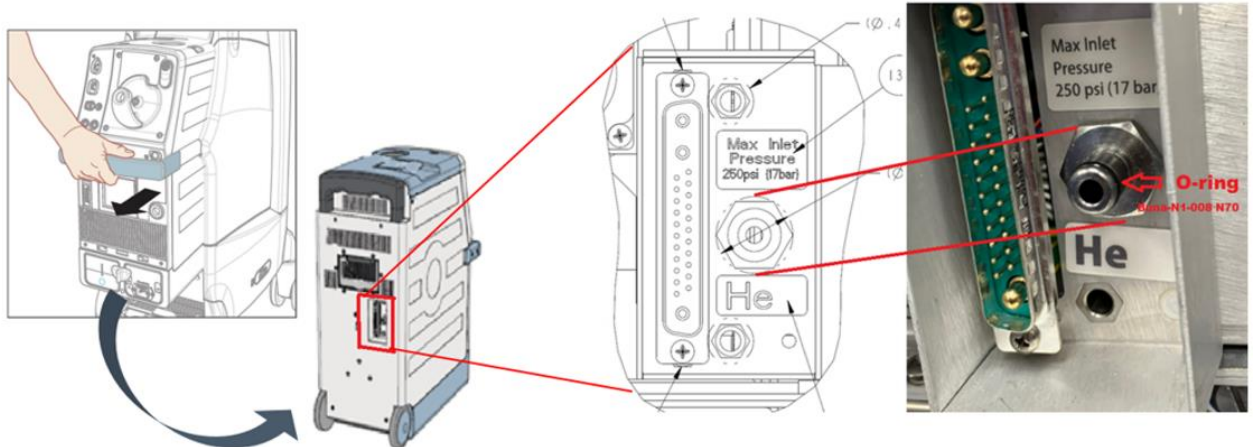
**Figure 3:** Drawings as pictured in **Cardiosave Hybrid and/or Rescue Operating Instructions**, along with a final picture of the O-ring as it appears on the unit.

There have been reports of damaged, worn, or torn O-rings on the Cardiosave Pump Console quick disconnect fitting resulting in helium tank leaks. The quick disconnect fitting is the point of connection that permits the refilling of the Pump Console's internal helium reservoir when the Pump Console is docked in the Hospital Cart. Please refer to images below for reference.

Datascope/Getinge has received 51 reported complaints of helium leak as a result of damaged, worn, or torn O-rings over a 2 year period.

1. If user observes any visual damage to the O-ring installed as part of the quick disconnect fitting, please contact your Datascope/Getinge service representative. If possible, remove the IABP from patient use until appropriate repairs can be made.

Datascope/Getinge is currently updating the annual Preventive Maintenance instruction to include replacement of the quick disconnect fitting O-ring.
