July 31, 2023

URGENT MEDICAL DEVICE CORRECTION
FSCA 2249723-06/02/2023-009-C & FSCA 2249723-06/02/2023-012-C
Datascope Cardiosave Hybrid and Rescue Intra-Aortic Balloon Pumps (IABP)

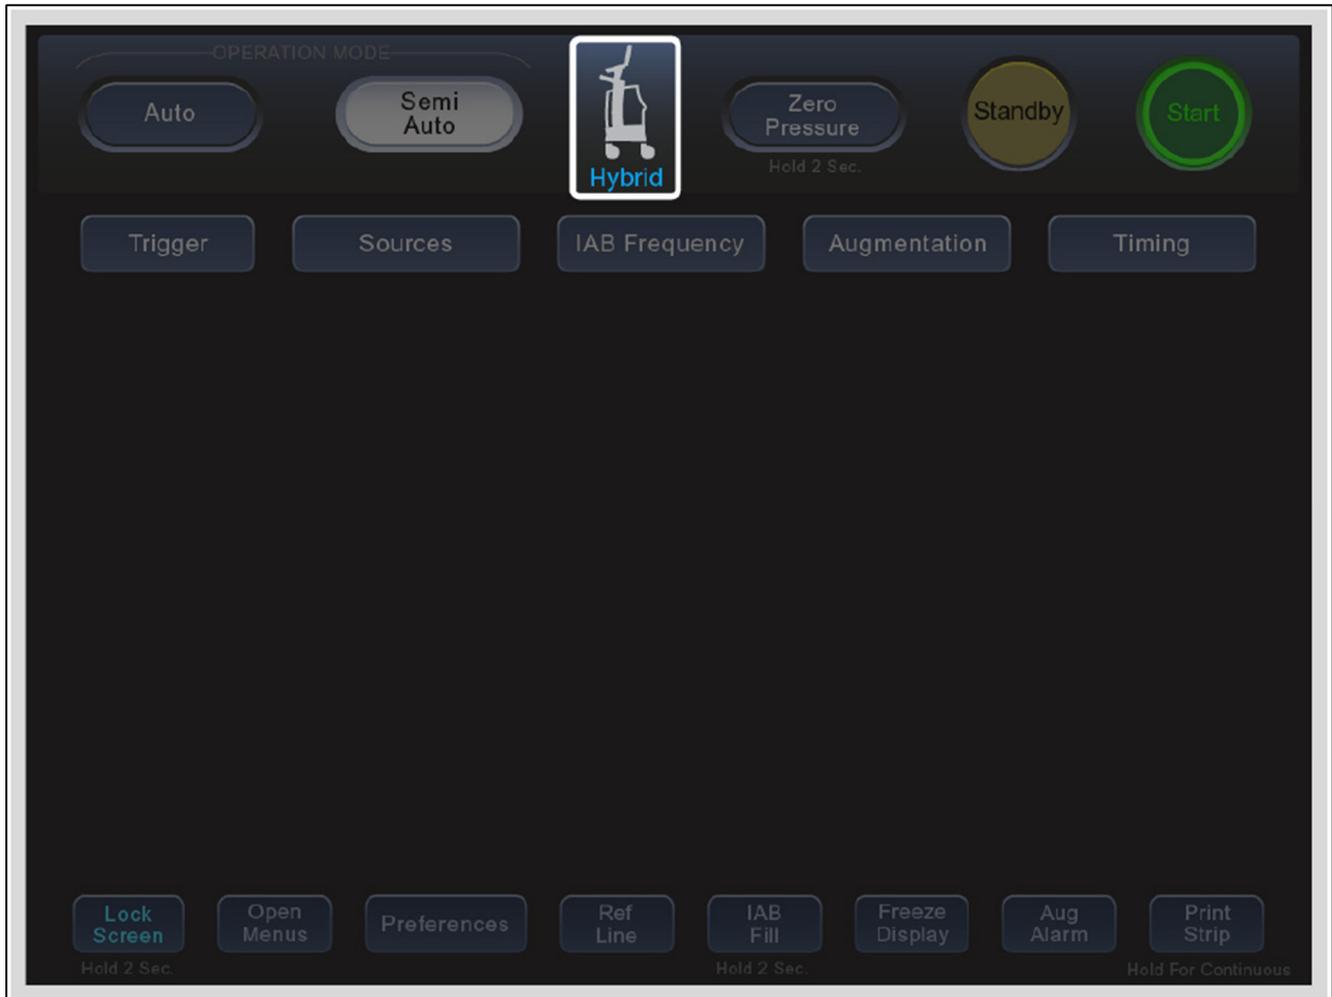
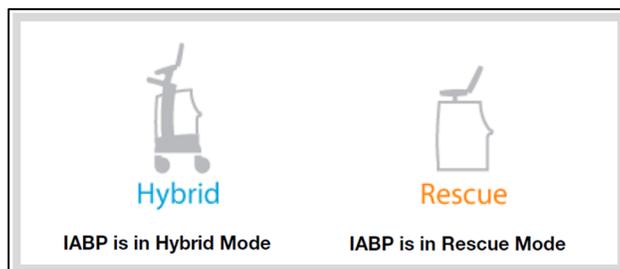
The IABP Configuration Icon shows the current mode of configuration for the IABP, Hybrid (in the hospital cart) Mode or Rescue (transport) Mode. The icon is located at the top center of the IABP display screen.

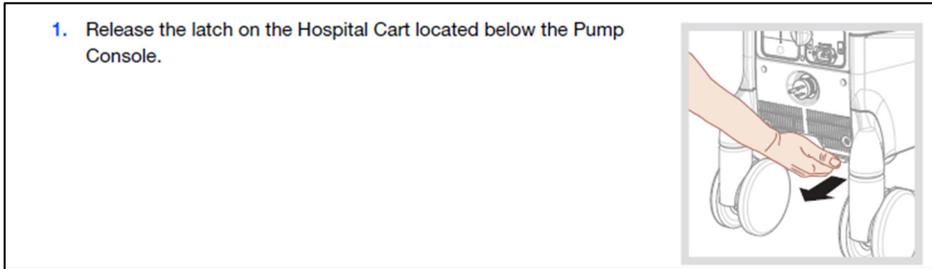
- 1) The Cardiosave Hospital Cart's release latch has been released and the IABP console is not properly installed in the cart.

If the AC Plug Icon is not present and/or the Rescue Icon is present, release the latch on the Hospital Cart located below the Pump Console, then grab the handle and slowly slide out the console approximately one quarter of the way.

Grab the handle and slowly slide the Pump Console into the Hospital Cart until it locks into place. You will hear an audible click noise and three audio tones of increasing volume will sound once the console is locked into the Hospital Cart.

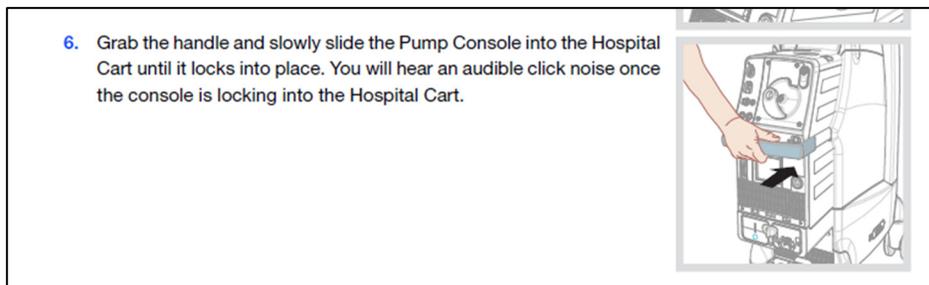
- 2) The IABP console is inserted into the hospital cart, but is not fully latched into the cart

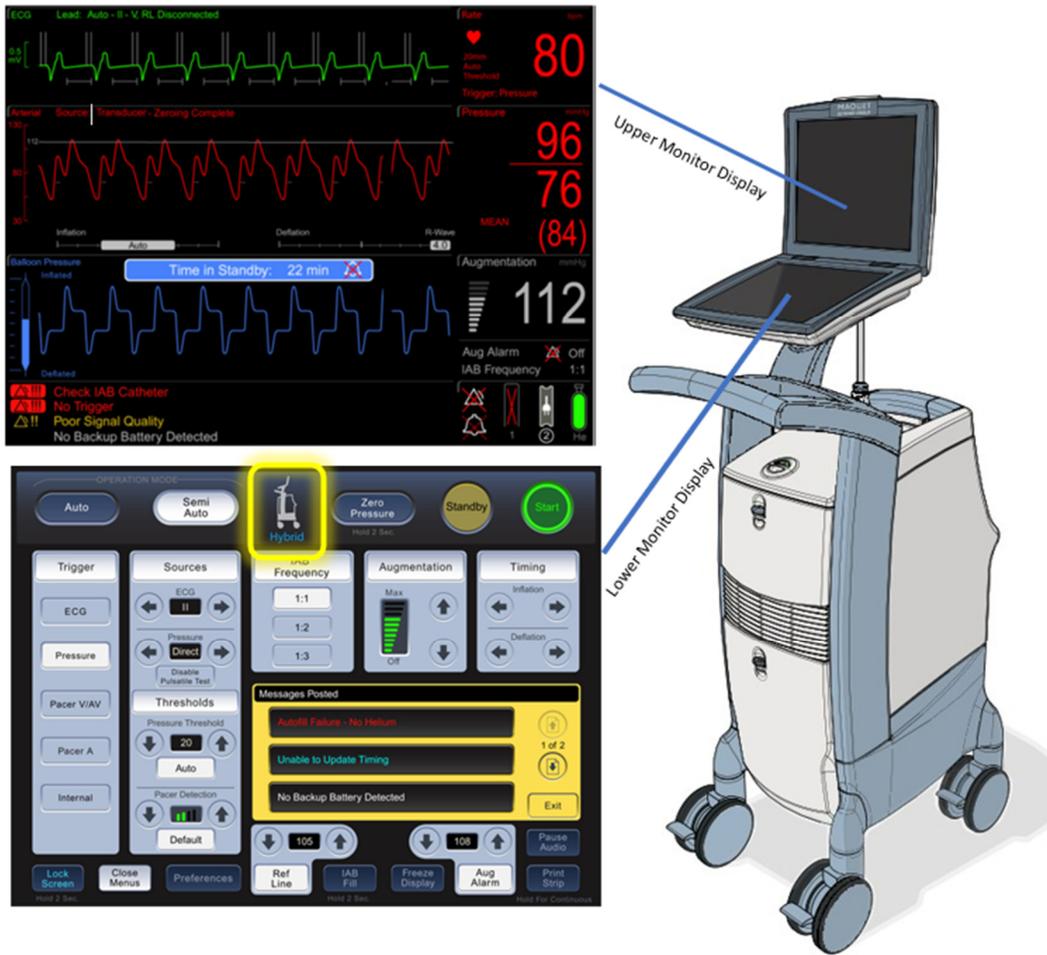
Cardiosave Upper and Lower Display

In both cases, information is provided to the user that the system is not in Hybrid mode via the Rescue Mode Icon on the bottom Cardiosave screen (top center of the screen). In addition, the “battery in use” message will be displayed in the informational message area even if the AC power cord is plugged in.

To ensure the Pump Console was successfully installed into the Hospital Cart, plug the Hospital Cart power cord into a compatible grounded AC receptacle, and confirm AC operation by checking the battery icon to confirm the pump is using AC power.
