Management of a Suspected Intra-aortic Balloon Perforation

Suspected IAB perforation

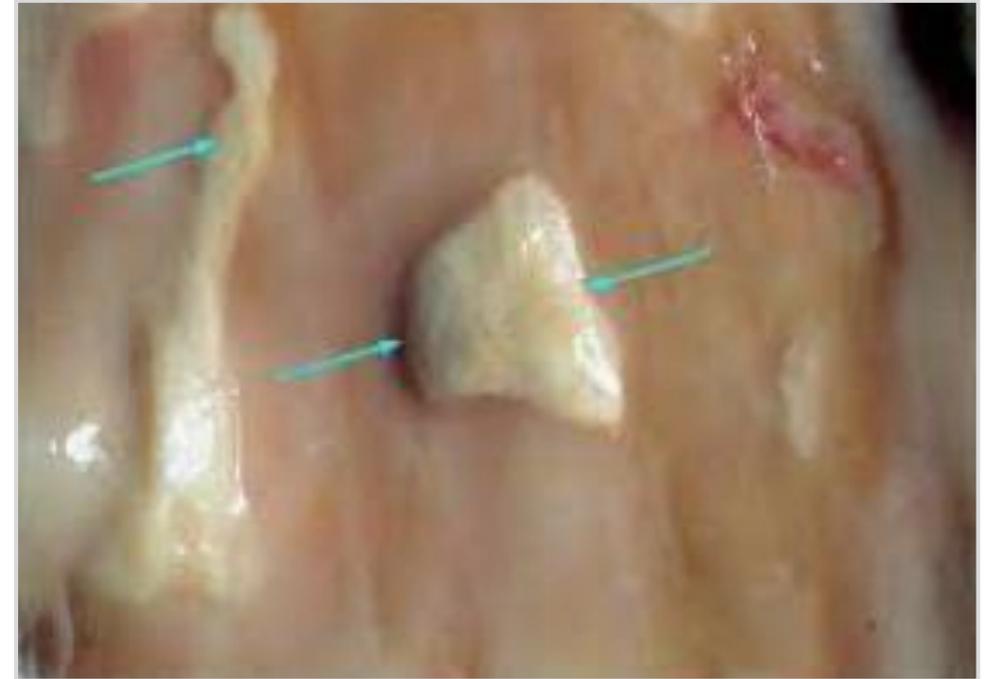
Calcific plaque in aorta

- Contact with a sharp instrument
- Fatigue failure due to unusual (biaxial) folding of the balloon membrane during use
- Contact with calcified plaque resulting in abrasion of the surface and eventual perforation

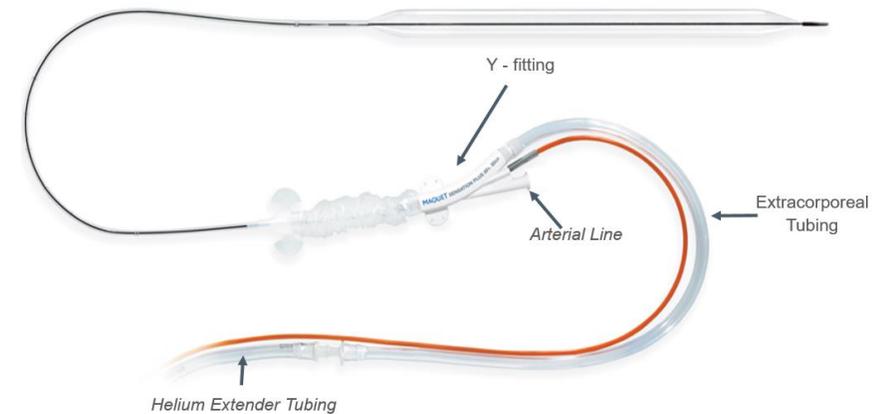
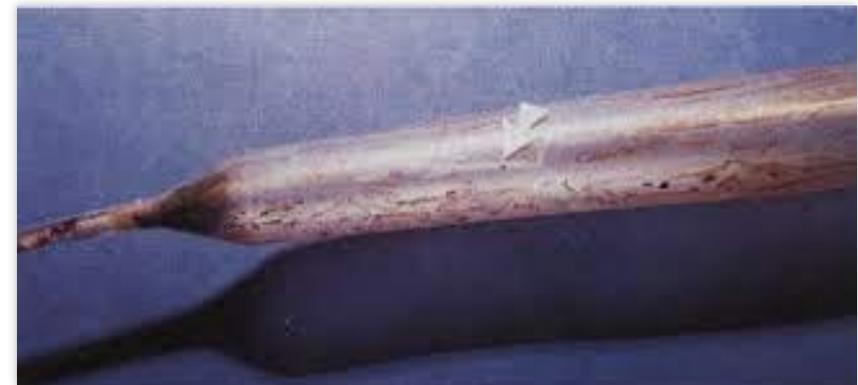
Evidence of blood

- Blood or fluid in the extracorporeal tubing or catheter extender indicated by:
 - Bright red blood
 - Dried blood particles
 - Serosanguineous fluid

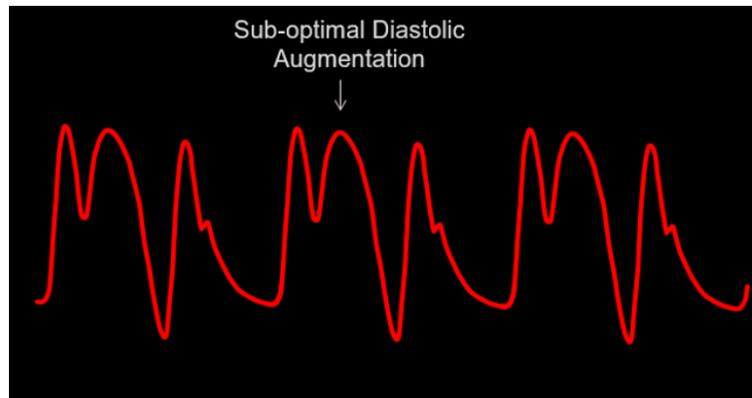
- Sudden change in the diastolic augmentation pressure

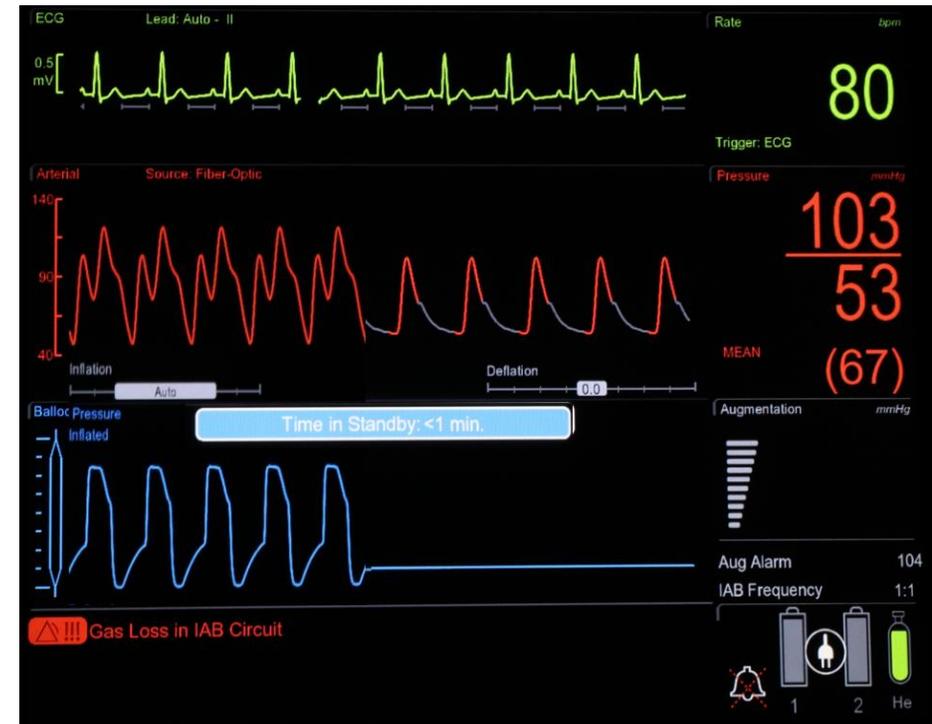
- Possible IABP alarms

During an autofill	Outside an autofill period
<p>Potential alarms:</p> <ul style="list-style-type: none">• Autofill Failure – Blood Suspected• Autofill Failure	<p>Potential alarms:</p> <ul style="list-style-type: none">• Gas Loss in IAB Circuit• Gas Gain in IAB Circuit• IAB Catheter Restriction

- Regularly inspect the IAB catheter tubing for the presence of blood during therapy and when the mentioned alarms occur.
- Do not disregard the alarms, and carefully heed the specified alarm's corrective actions.
- These alarms play a crucial role in potentially detecting a perforated balloon earlier, preventing the possibility of blood entering the IABP system.
