Management of a Suspected Intra-aortic Balloon Perforation

Suspected IAB perforation

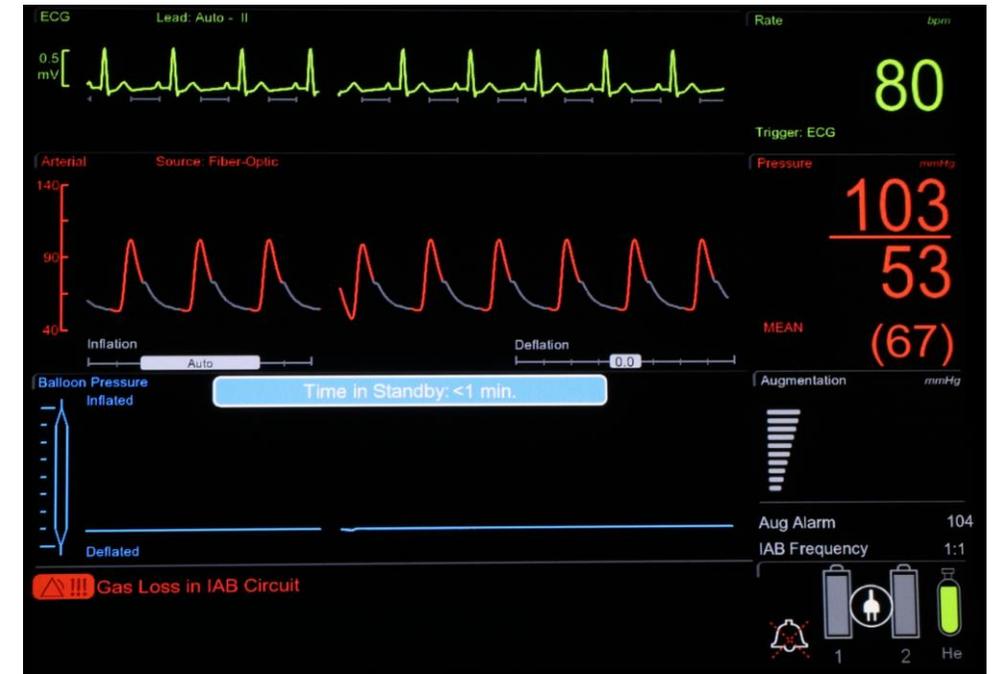
Risk to health

- An unexpected shutdown can occur if blood is permitted to enter the Cardiosave IABP. This event is referred to as a “blood back”.
- This may threaten the hemodynamic stability of the supported patient as the user is left unaware of the status of the IABP.
- Additionally, any subsequent attempts to use the affected console that experienced a blood back event without reconditioning may delay future therapy delivery.
- The user and subsequent maintenance or service personnel can be exposed to an unexpected biohazard if proper containment precautions are not taken.
- Subsequent patients may be exposed to an unexpected biohazard if an affected console is not appropriately serviced prior to use.
