URGENT FIELD SAFETY NOTICE
MEDICAL DEVICE FIELD CORRECTION
Maquet/Datascope CARDIOSAVE Intra-Aortic Balloon Pump (IABP)

AFFECTED PRODUCT	PART NUMBER	DISTRIBUTION DATE
Cardiosave Hybrid IABP	0998-00-0800-XX & 0998-UC-0800-XX (excluding 0998-00-0800-83, 0998-UC-0800-83 & 0998-00-0800-75)	March 06, 2012 through April 26, 2018

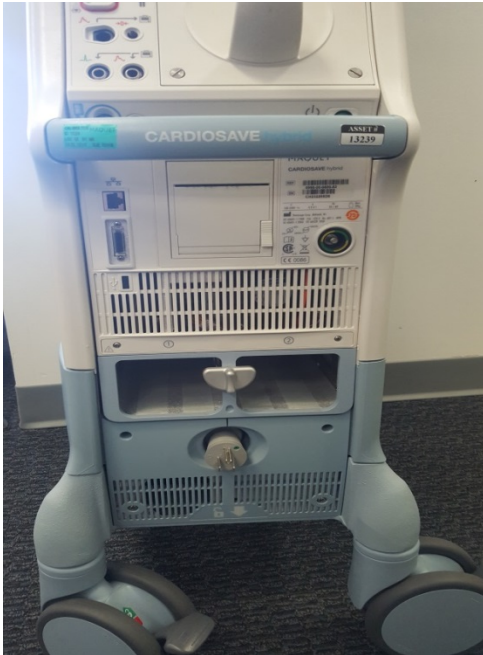
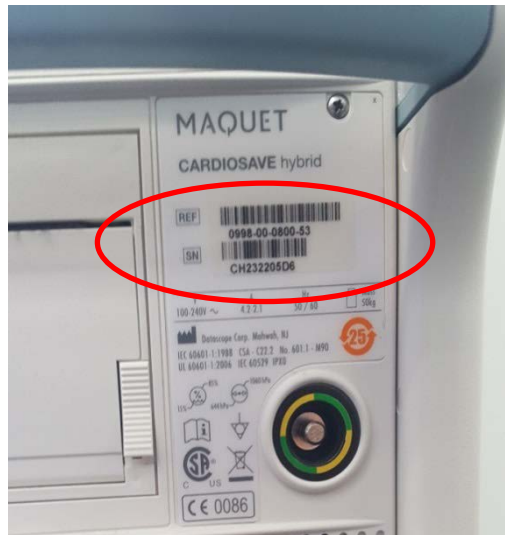
Figure 1: CARDIOSAVE IABP – Location of Part Number (REF) and Serial Number (SN)

CARDIOSAVE IABP units are serialized. The part number and serial number can be found on the front panel of the CARDIOSAVE IABP unit. Please refer to **Figure 1** on page 3 for a depiction of the CARDIOSAVE IABP and the location of the part and serial numbers.
